TETHERED AEROSTAT RADAR SYSTEM

Tethered Aerostat

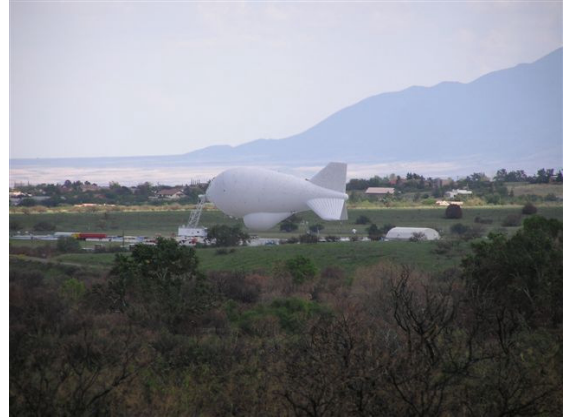
Replacement Aerostat Being Checked Out & Returned to Service

Fort Huachuca Aerostat Accident – Another example of the aerostat’s vulnerability to high winds occurred on the afternoon of 9 May 2011 when the aerostat broke loose from its tether and disintegrated over the city of Sierra Vista. Components of the aerostat came down in the Canyon Del Flores neighborhood of Sierra Vista. The Fort Huachuca Garrison Commander indicated that aerostat debris was recovered from about ten different locations in the neighborhood. The accident resulted in no personnel injuries and only minor property damage. The aerostat was replaced in August 2011 and was returned to service in September.
