TETHERED AEROSTAT RADAR SYSTEM (TARS)

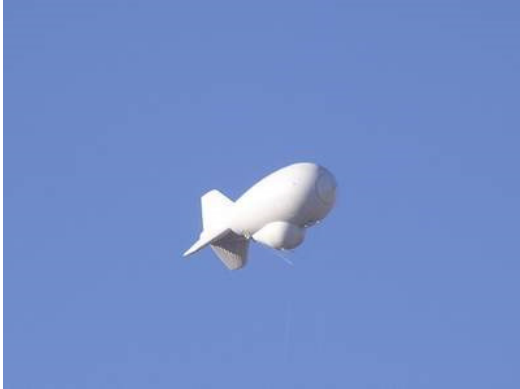
Figure 1. Tethered Aerostat

The aerostat consists of four major parts or assemblies: the hull, the windscreen and radar platform, the airborne power generator, and the rigging and tether assembly. The radar weighs

about 2200 pounds and has a detection range of 200 miles. The hull contains two parts separated by a gas tight fabric partition. The upper part is filled with helium and provides the lifting capability. The lower chamber is a pressurized air compartment that maintains the shape of the hull at all altitudes. The aerostat is generally deployed at altitudes of around 10,000 feet and is tethered to the ground by a nylon fiber cable with a tension strength of 35 000 pounds.

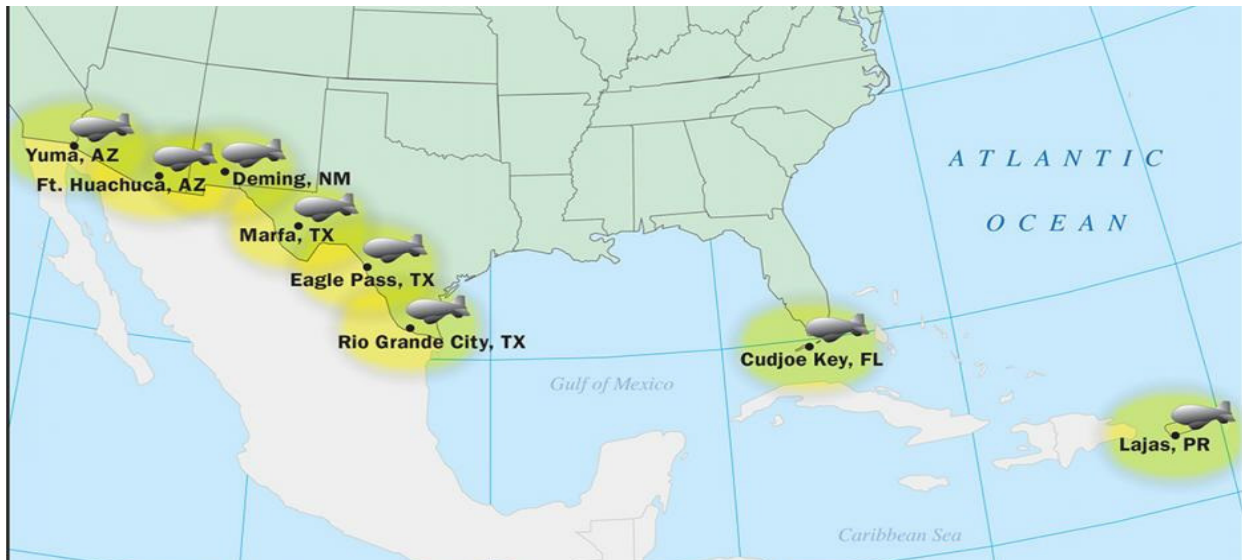
Figure 2. Tethered Aerostat Radar System Site Locations

aerostat went operational at High Rock Grand Bahama Island in 1985. Their second site to go operational was at Fort Huachuca in 1986. Prior to 1992, three different agencies operated the TARS network: the Air force, the Customs Service and the US Coast Guard. In 1992, the Air Force was assigned responsibility for managing the TARS network. Fourteen sites were initially activated. By 2000, two of these sites had been deactivated. In July 2001, the Air Force announced that three more sites had become non-operational. In July 2013, management of the TARS network was transferred to US Customs and Border Protection, an agency under the Department of Homeland Security. As of October 2016, eight TARS sites were still operational. These locations were Yuma AZ, Fort Huachuca AZ, Deming NM, Marfa TX, Eagle Pass TX, Rio Grande City TX, Cudjoe Key FL and Lajas PR. Their locations are depicted in Figure 2.

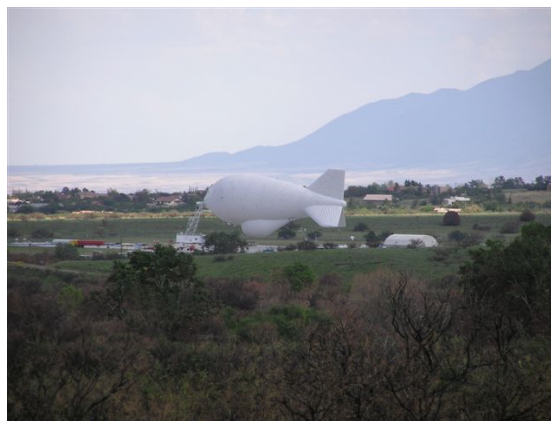
Figure 3. Replacement Aerostat Being Checked Out & Returned to Service

Fort Huachuca Aerostat Accident – Another example of the aerostat’s vulnerability to high winds occurred on the afternoon of 9 May 2011 when the aerostat broke loose from its tether and disintegrated over the city of Sierra Vista. Components of the aerostat came down in the Canyon Del Flores neighborhood of Sierra Vista. The Fort Huachuca Garrison Commander indicated that aerostat debris was recovered from about ten different locations in the neighborhood. The accident resulted in no personnel injuries and only minor property damage. The aerostat was replaced in August 2011 and was returned to service in September (see Figure 3).
